Leak History #44 High Pressure Feedwater Heater Valve

- Problem:** Vent Valve
- Boiler:** High Pressure Feedwater Heater
- Equipment:** Single Metalborne Waveguide

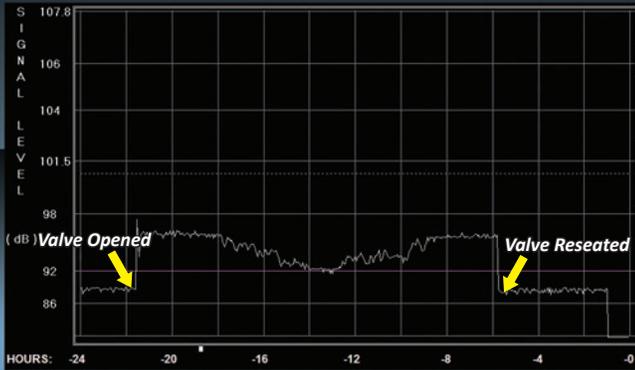
SENSOR 34 ACOUSTICS

The plant noticed an unusual step increase on sensor 34, a feedwater heater sensor, and asked MISTRAS | Triple 5 for additional analysis. The MISTRAS | Triple 5 analyst reviewed the data and compiled a report*; specifically asking the plant if there were any valve changes or vent openings at the time of the step increase, 29 June 19:20. With that guidance, the plant then proceeded to investigate operational changes at the time of the step increase.

**Sensor 34 signal stepped to 97dB, from 89dB, 06/29/16 1920 and is currently trending near 94dB. The spectrum shows narrowband lifting from the reference 50kHz – 75kHz bandwidth at this time. Current levels are higher than the past 60 days. Were there any operational changes at that time (06/29/16 1920) that we can correlate to the acoustics? For example; level changes, valve position changes, vent openings, etc.? Recommend walking the heater as well as continued monitoring.*

While reviewing the shift summary report, the plant noted that the heaters and DA vents were opened at the time of the step increase for a period of five minutes. Operators then physically inspected the vent valve and discovered there was a “hissing” sound emanating from the vent. The operator was able to reopen and reseal the valve, causing the “hissing” to stop. There was a corresponding drop in the acoustics and, given the valve was difficult to manipulate, a work order was entered to replace the valve.
